SMITHSONIAN INSTITUTION
BUREAU OF AMERICAN ETHNOLOGY

Field Notes

NIAP of MITLA

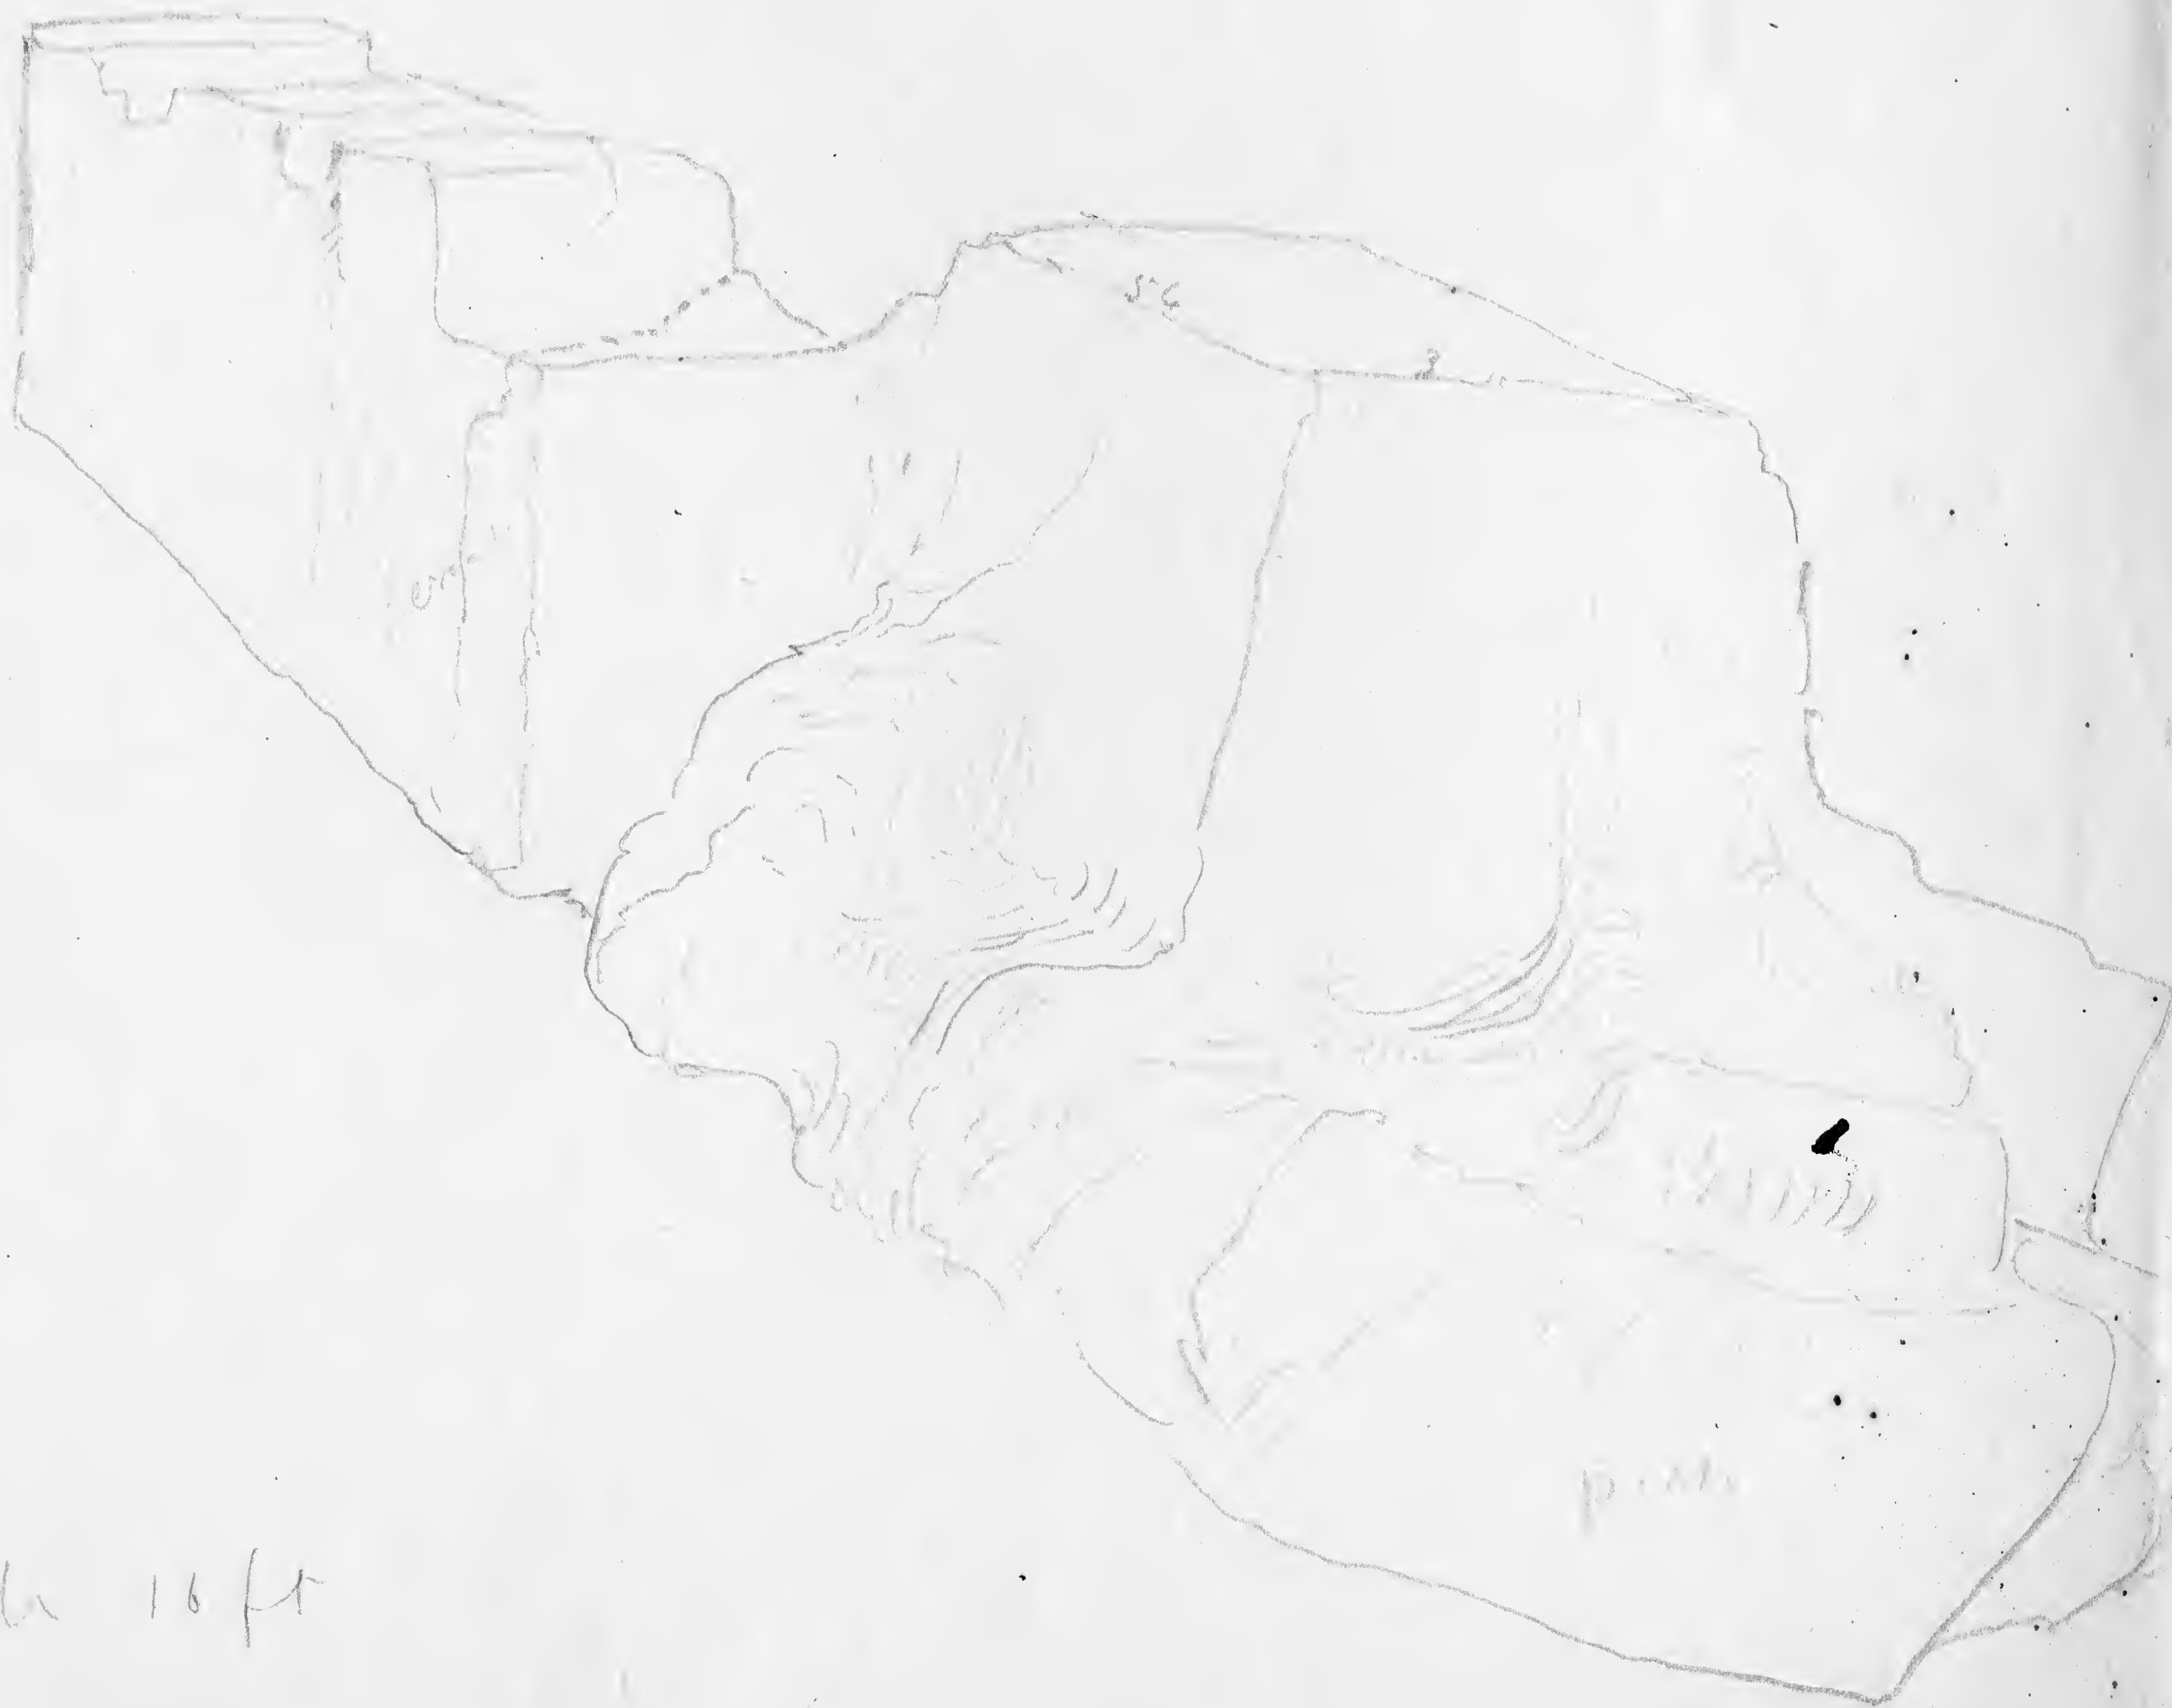
Surface all cut

full under 16 ft
high 73

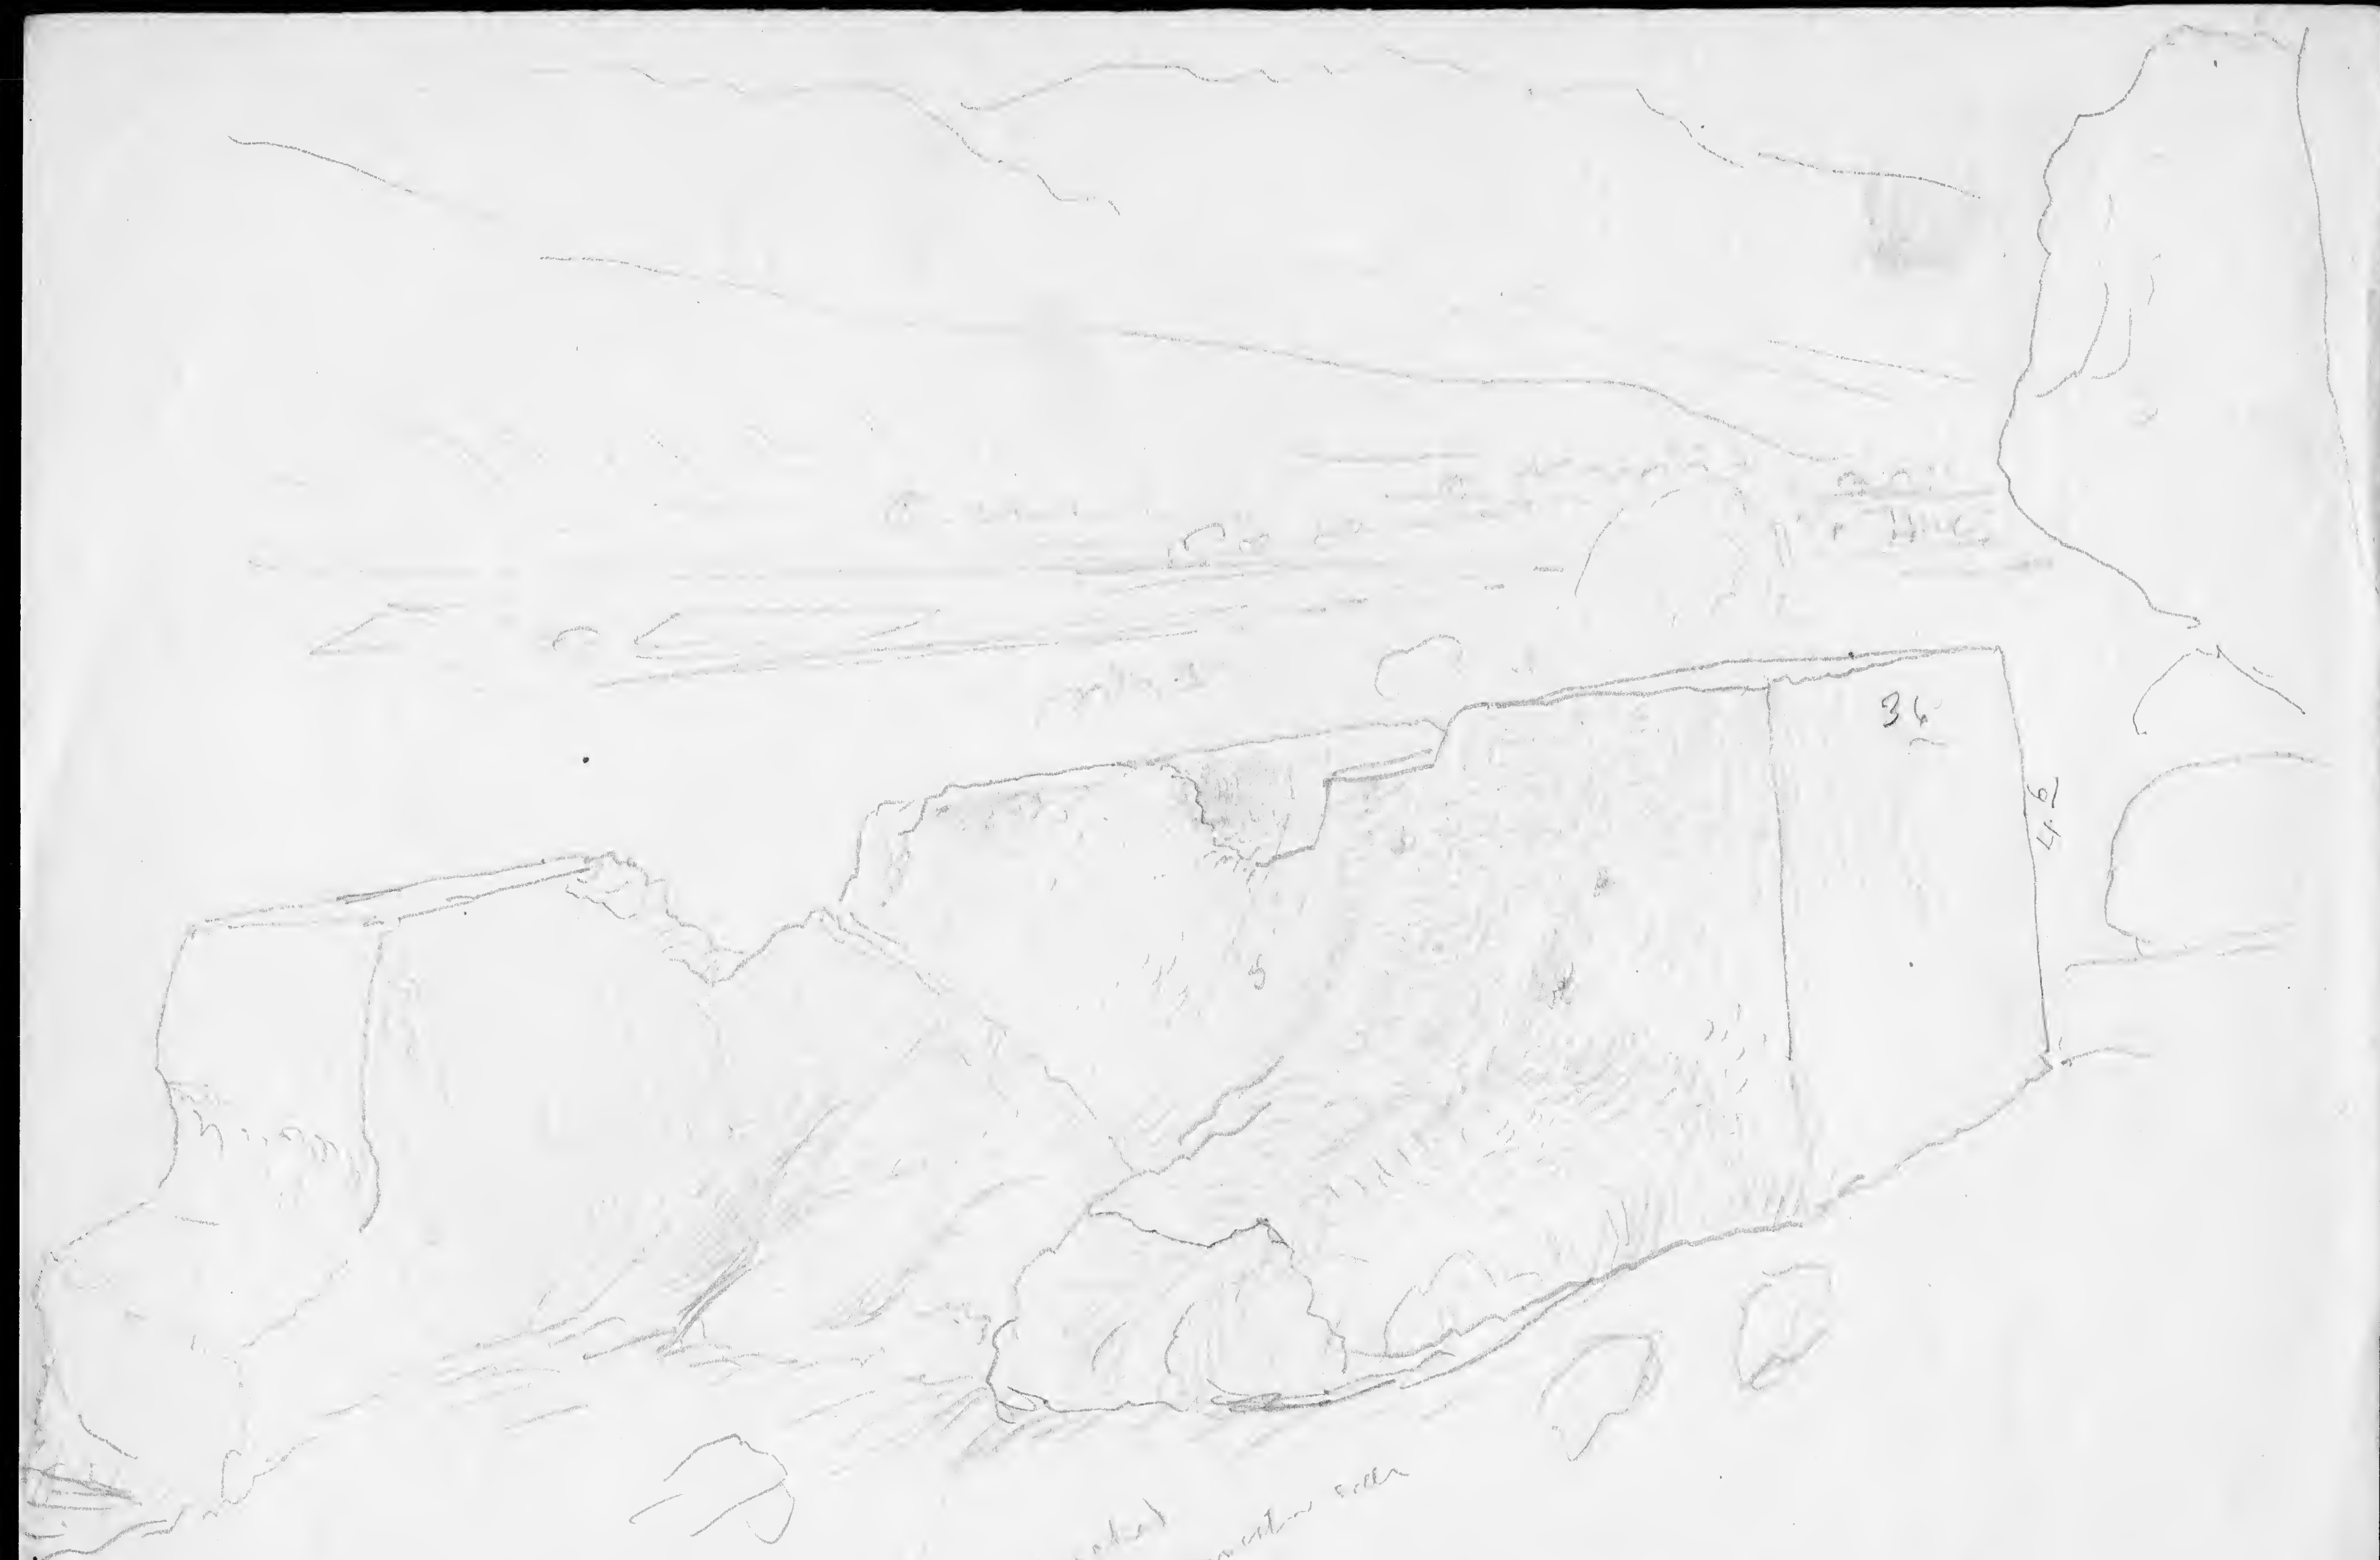
End deep in ground

roughly marked
approximately mountain side

22 or 23 long

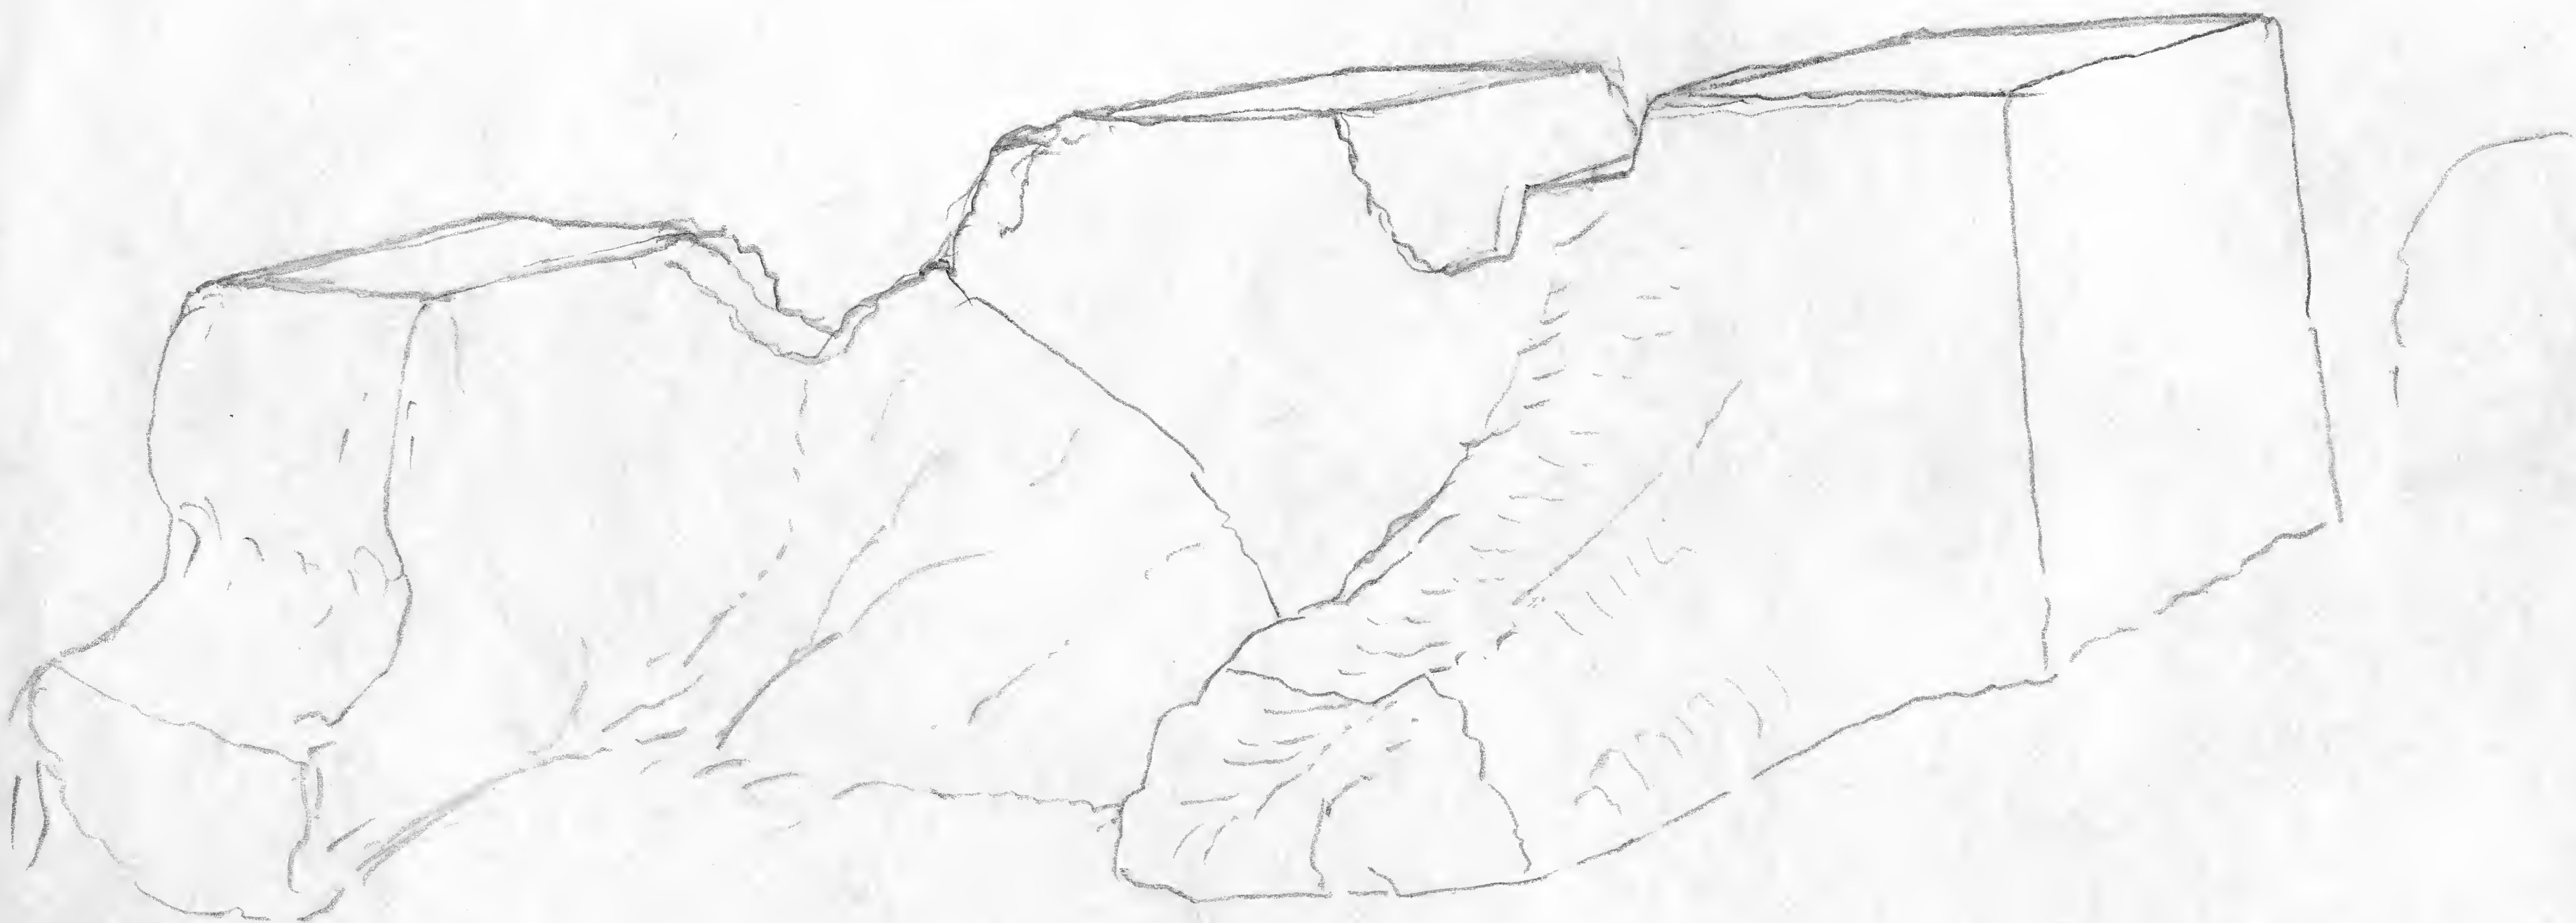
Fortified hill
1 mile west of Multa

A all adobe
B rock platform
C Stone Mound
D Traces of adobe with stone base

E. F. remnants of stone walls

In the sketch ^{map} ~~plan~~, fig x, a rough idea is
given of the ^{ground plan of the} fortification on the ~~upper~~ slopes of
the hill. Our ~~visit~~ was hurried and ~~at the~~
survey was ^{not undertaken} ~~made~~ as a second visit was
contemplated; but the second visit was not made,
~~and this is much~~ ^{regretted} as I find that
the maps made by previous visitors, especially
by the early explorers are far from satisfactory.

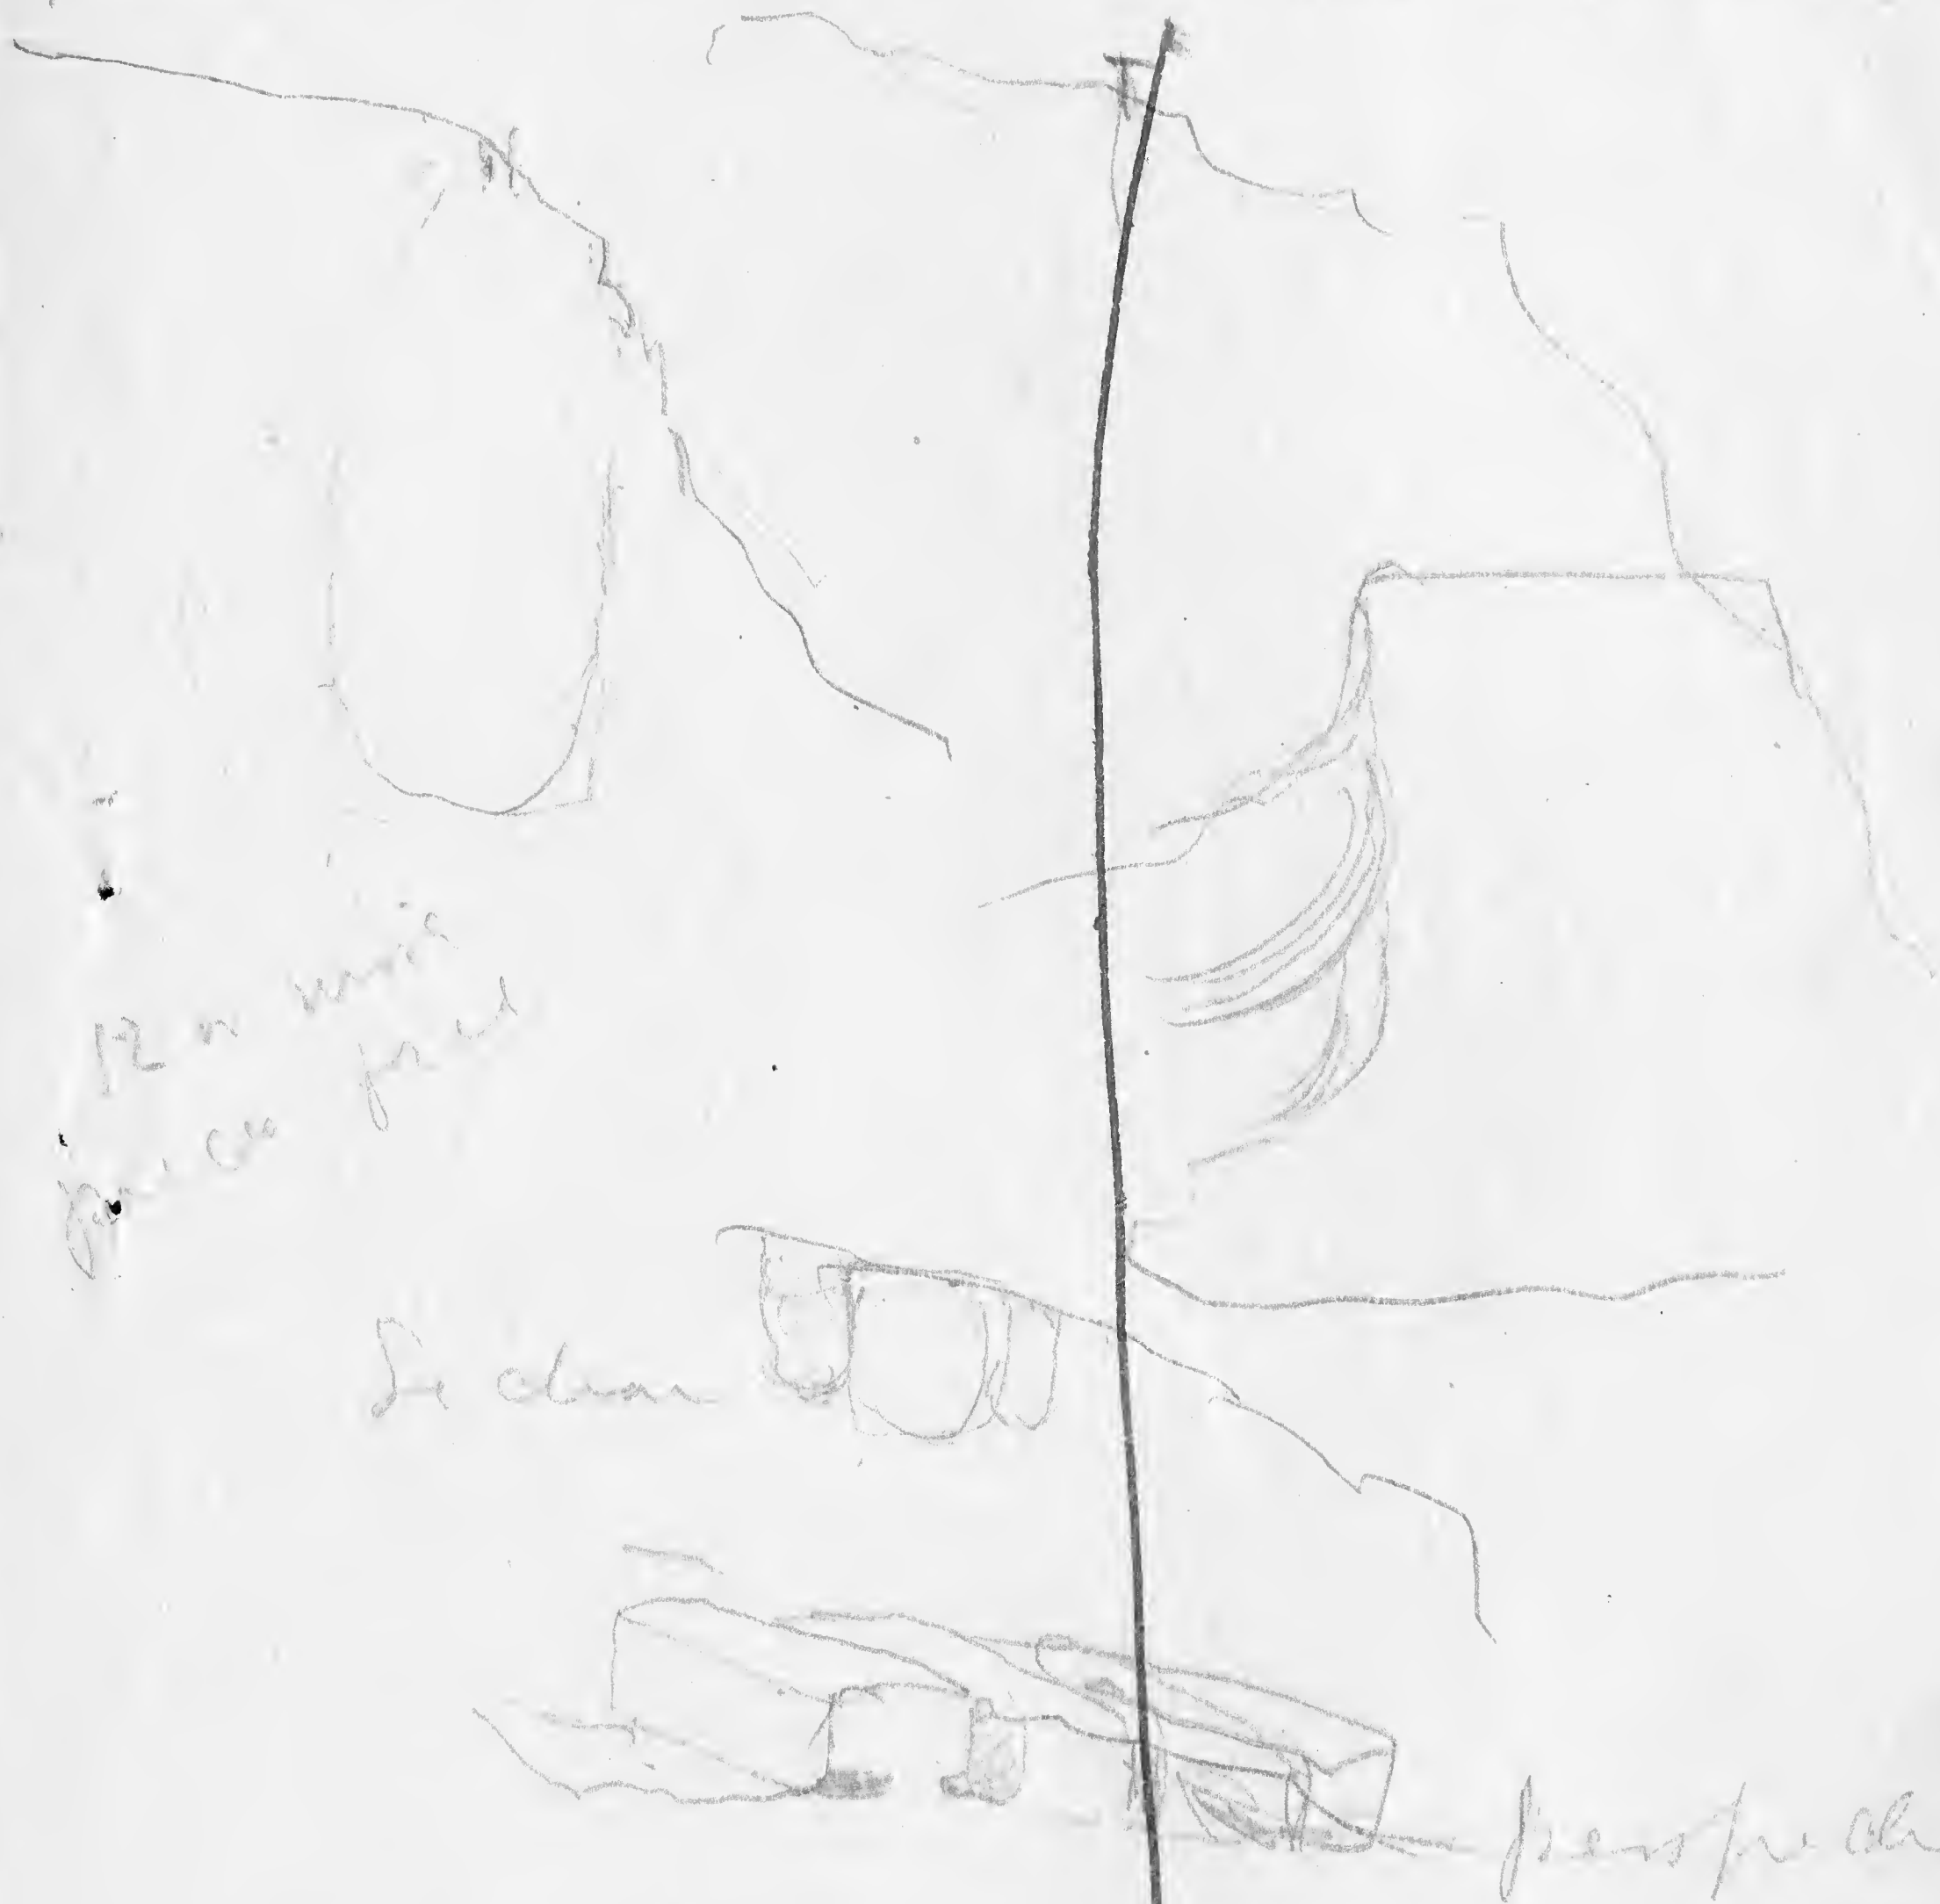
Fig 8 Method of cutting out
blocks of trachyte in quarry
drawn from description of Mr
Thompson.

Made observations of the upper
quarry while I visited the
workings along the lower bluffs
He found that the quarrymen
had attacked the massive rock
in place and removed the blocks
